St. Chrysostom's Episcopal Church

Client Brief: The church's nave, exterior walls and courtyard required substantial repairs and maintenance; additionally, the organ originally housed in one of the aisle corners at the front of the church was to be replaced by a new C.B. Fisk organ located toward the rear of the nave. It was intended that this new position would prove more visually dynamic, flanking the sides of a magnificent stained glass window crowned by a rose.

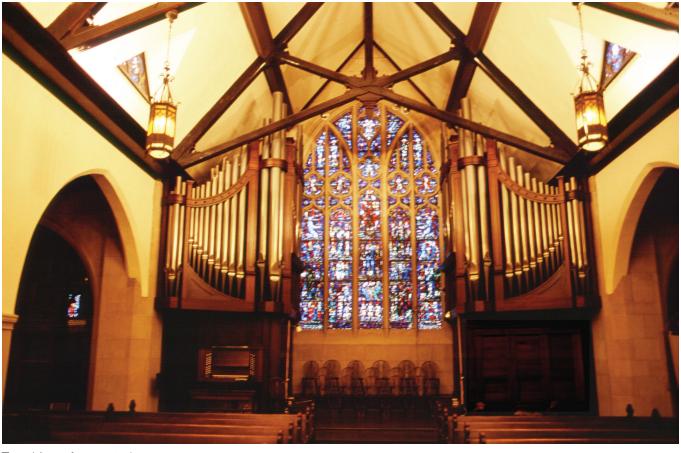
Top: View of renovated nave

ginal character. Likewise, the trusses and the plaster ceilings were restored and repaired, substantially improving the acoustic qualities of the church. A number of rooms in the basement were redesigned to add support space for the church, specifically through the inclusion of green rooms and rehearsal rooms. Finally, the entrance sequence of the church was also improved through a complete restoration of the glazing of the cloistered hall at the end of the open courtyard.

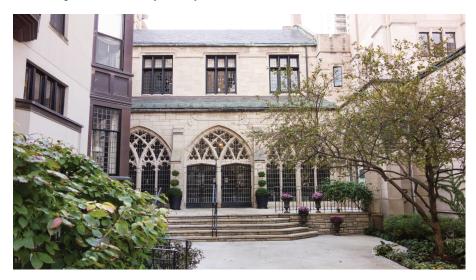
Top & Bottom L: Renovated stone and glass window in cloister Bottom R: Views of Stained window

The primary design intent was to restore the church in a manner that would complement a wonderfully designed pipe organ. With the assistance of some of the finest artisans in Chicago, the nave and rose windows were restored and are now properly vented and protected in accord with modern standards. Additional research conducted during the cleaning of the tile flooring restored the surface's ori-
